Historic Lighthouse Preservation Handbook

1997

Introduction

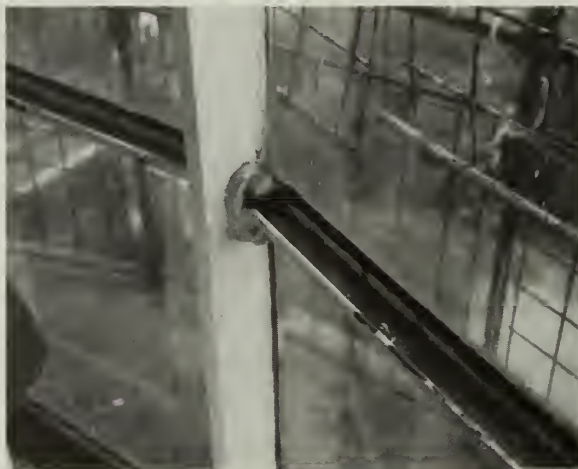
Figure 3 (above). Horizontal mullions run in between the stiles and serve to keep the stiles straight and frame the individual pieces of glass. Before restoration, the mullions and sills had been bolted in place over 140 years.

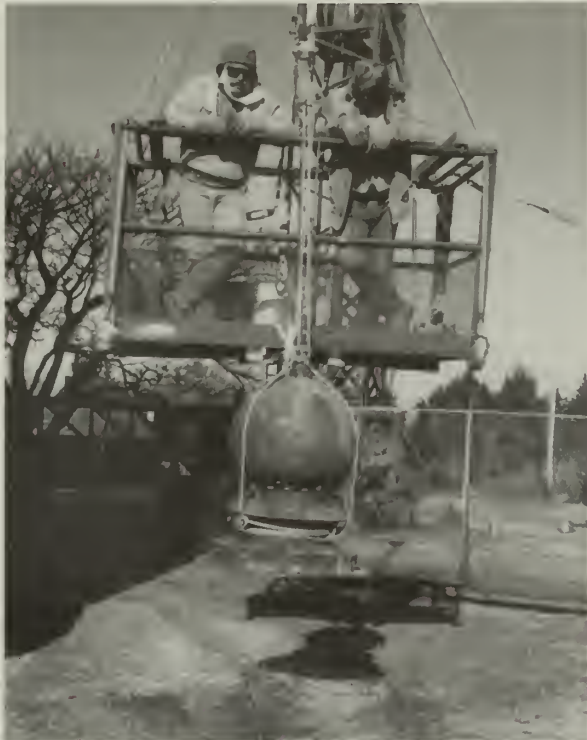
Figure 4. The first step in removing the roof was to take off the vent ball. The vent ball not only serves as a lightning rod but also provides ventilation to the glass in the lantern room, limiting condensation.

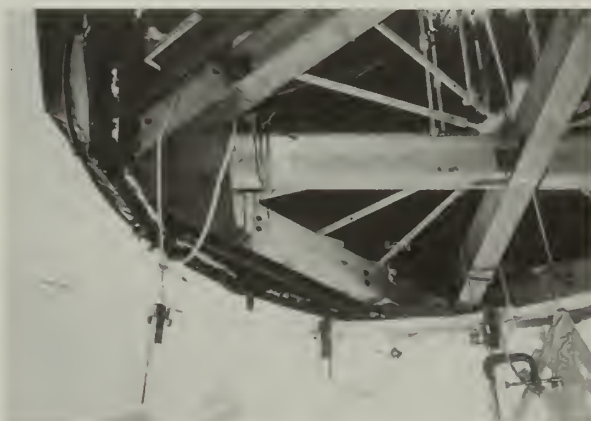
Figure 5. As the roof is being removed from the lighthouse, the tie rod system, supported by ICC's aluminum roofing frame, is visible. This frame was designed to fully support the roof and alleviate any stress or strain on the roof during the lift. Protruding down from the roof are the ends of the rafters which connect to the top of the stiles.

In Buffalo, extreme care was required to restore the roof without compromising dimensional integrity of the 16 tie rods and 16 roof rafters. The roof would be reinstalled in the same position, mating in 16 individual points, bolting together in 48 individual machined holes. The roof measured over 13 feet in diameter; restoration included replacement of the original cornice brackets that held the roof to the window wall and kept the shape of the copper. A 1/16-inch difference at each location would add up to a one inch deviation, preventing the roof from fitting.

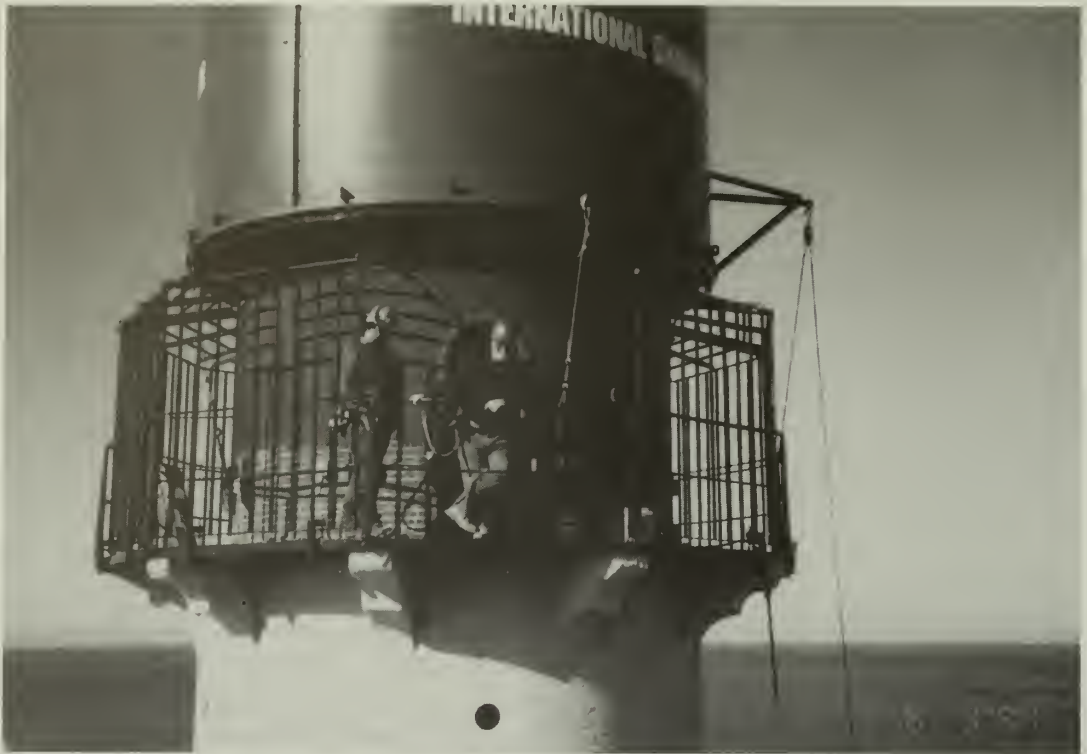
Figure 6. During the restoration, this 'Campbell Soup Can' was installed over the lantern room in order to protect restoration efforts from the environment.

Necessity is truly the mother of invention. The job was replanned to include disassembly of the roof only and rework of the lantern in the field. A large temporary steel enclosure, affectionately referred to as the 'soup can', was fabricated to fit over the window wall system and allow craftsmen to work in relative comfort during the coldest winter in Cape May history. The temporary steel enclosure, designed to accommodate both interior lighting and ventilation, was installed on a

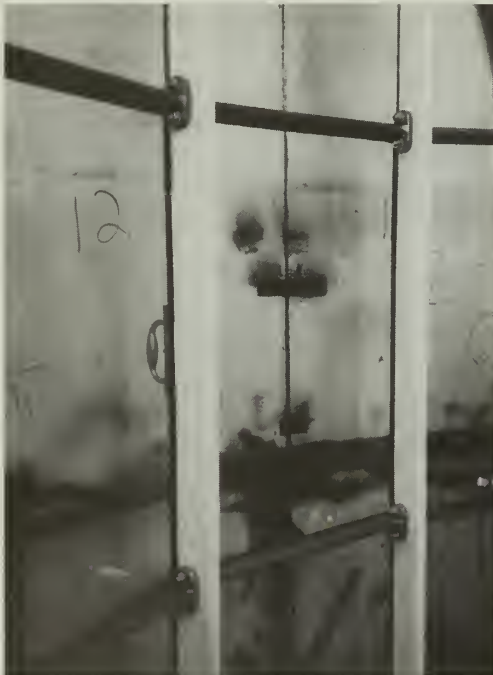
Figure 7. Inside the lantern room, the mullions have been reworked and reattached to the stiles. New stainless steel bolts have been used to prevent corrosion and teflon tape has been used as a gasket between the bronze and the cast iron. Teflon washers also separate the bronze from the stainless steel bolt.

In June 1994, all preparations were complete for reassembly of the lantern room and roof system. The matched, marked pieces were carefully refitted with new stainless-steel hardware and teflon tape which acts as an isolator between the dissimilar bronze and cast-iron metals. In the 19th century, little was known about the chemical reaction between dissimilar metals. When a copper-based metal is placed in contact with a ferrous-based metal, an anode-cathode reaction occurs, similar to a battery. This changes the molecular structure of the ferrous metal, causing corrosion.

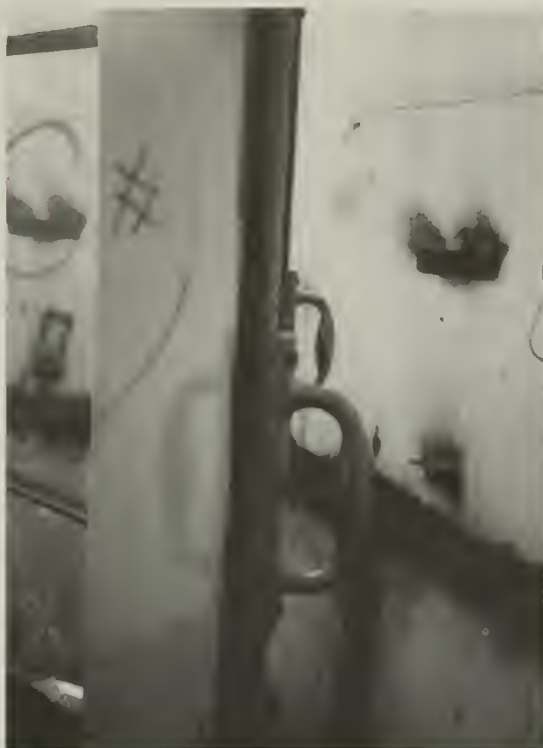
Figure 8. New hand holds were replicated to replace missing pieces. These exactly match the originals.

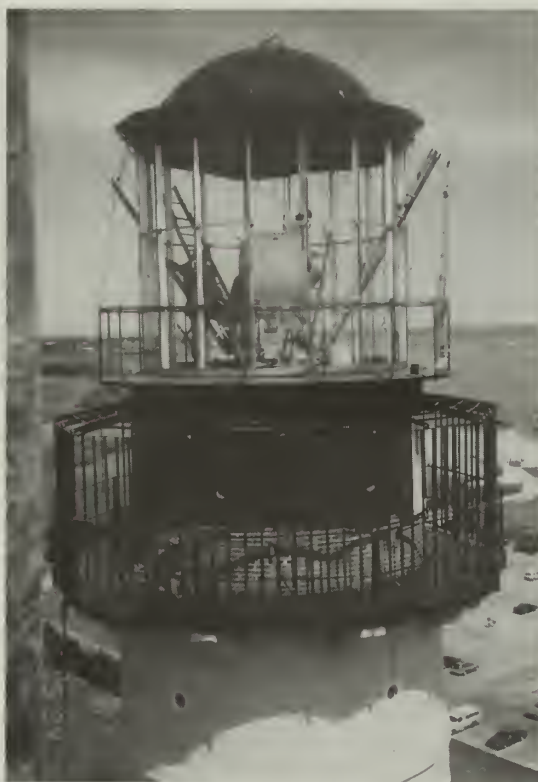
Figure 9. The refurbished roof is replaced on the lantern room. The fit is almost exact.

Meticulous preparations were made on the ground and in the air for the lift. The refurbished roof was centered as close as possible to the center line of the lighthouse and turned to allow for the proper fit in its original position. ICC's craftsmen were perched on ladders waiting for the roof to be hoisted. When all was ready, the signal was given and the lift began. The roof was centered above the window wall and began its descent. The result was anticlimactic. The roof came down exactly into position as if sucked in by a giant magnet. The major portion of the restoration was complete.

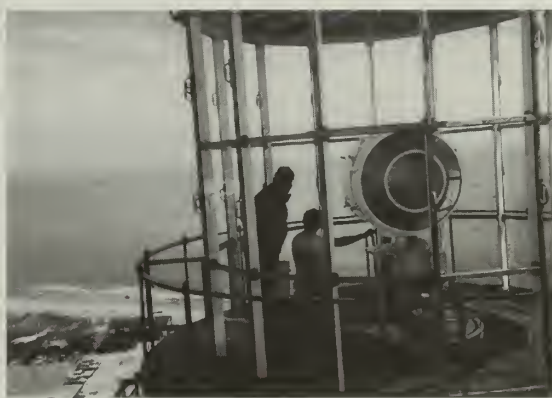
Figure 10. All glass is now in place and final preparations are made for the reopening.

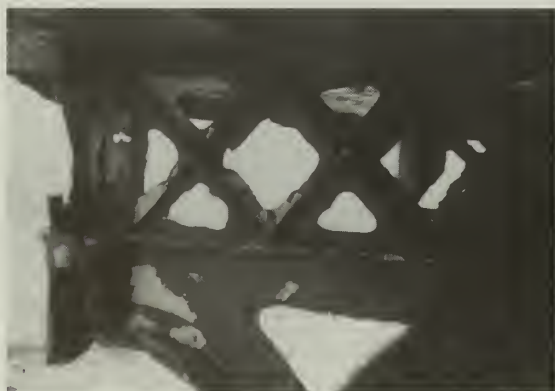
Figure 12. Some brackets were so deteriorated that they were totally exposed to the elements.

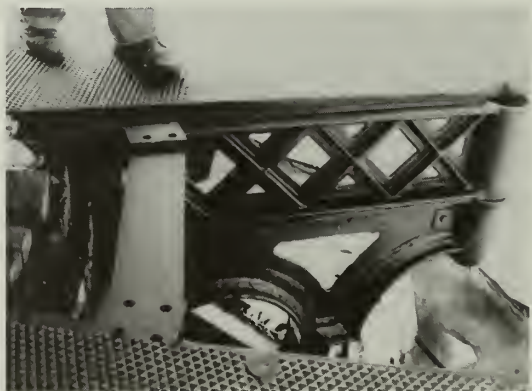
Figure 13. After the most severely deteriorated portion of the brackets were removed, new cast-iron pieces were made and installed; and new deck plates installed.

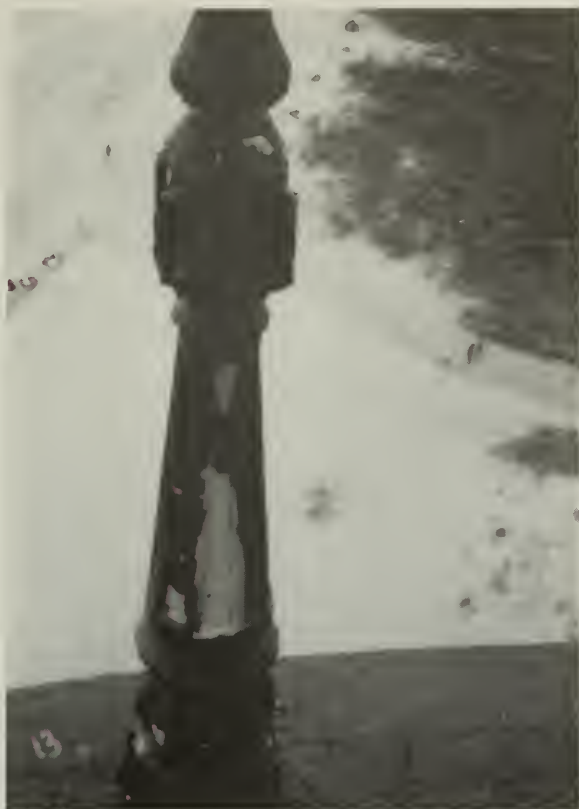
Figure 14. The handrail assembly has been removed and the ornate cast-iron post is ready for removal.

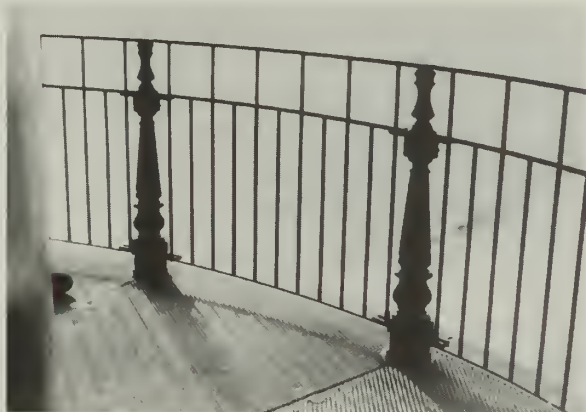
Figure 15. A replica handrail is installed.

When repairs were completed to the Bonner Bridge, exterior work could begin. A 7-foot-wide, circular work deck was placed below the large gallery deck. This afforded access to the complete hand rail system and deck plates. The hand rail components were carefully removed, as were the deck plates. The surviving pieces of deck plate were so deteriorated that accurate measurements could not be made. The deck was recalculated and a template made of the theoretical size and shape of the new deck plates. This was custom-fitted to each individual bracket, revealing that the lighthouse was slightly out of round. Measurements were taken for each individual section, which required custom casting, machining, and fitting of each individual section of plate. The brackets supporting the plate were reworked, and individual components recast. The belt course holding the brackets together below was removed, the masonry underneath repinned, and the cast belt course reinstalled. Deteriorated masonry was carefully cut out and repainted, as was the granite pedestal at the base.

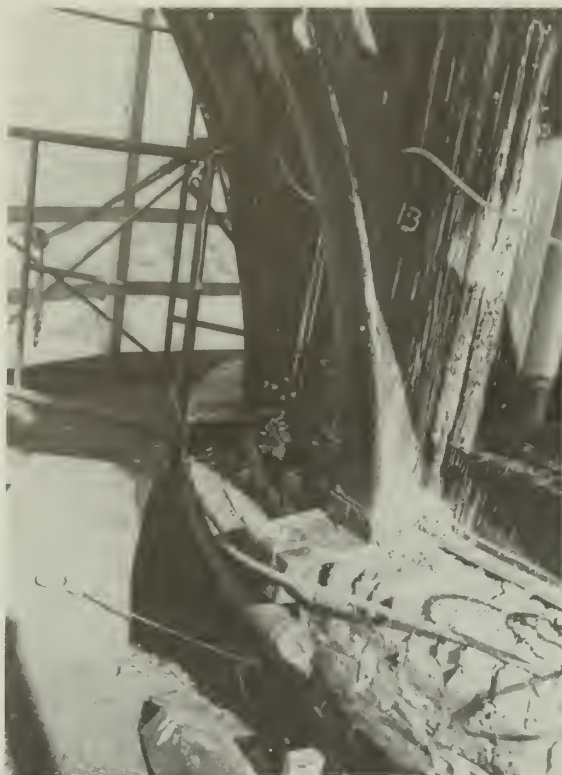
Figure 16. At the base of the brackets, the cast-iron belt course is removed, exposing deteriorated masonry below.

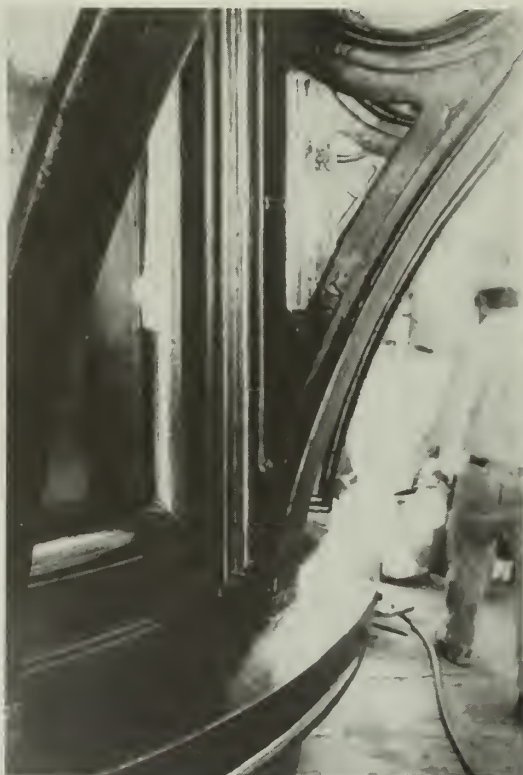
Figure 17. The cast-iron belt courses are repinned to new masonry beneath.

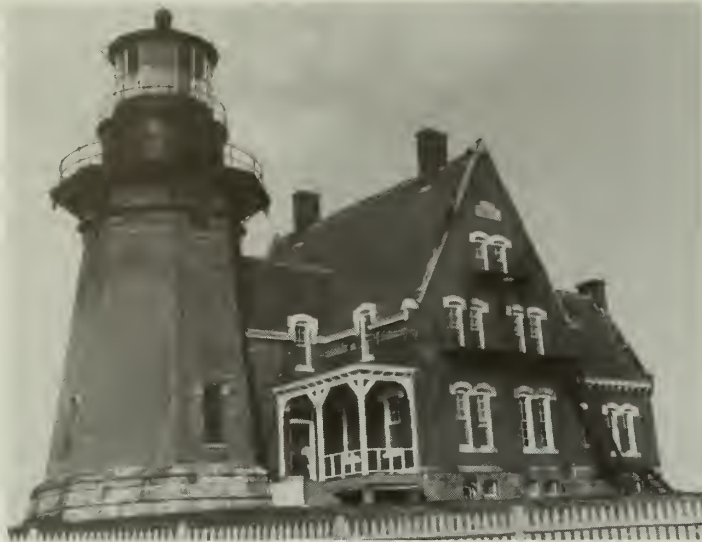
Figure 11. Block Island Southeast Light Station before the move.

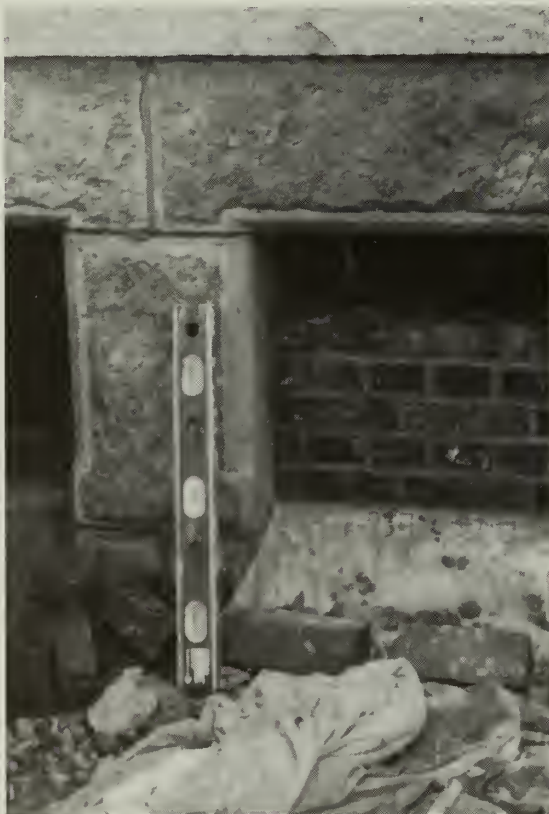
Figure 12. In preparation for the move, the cellar windows openings are temporarily bricked in to stabilize the masonry above the lift point.

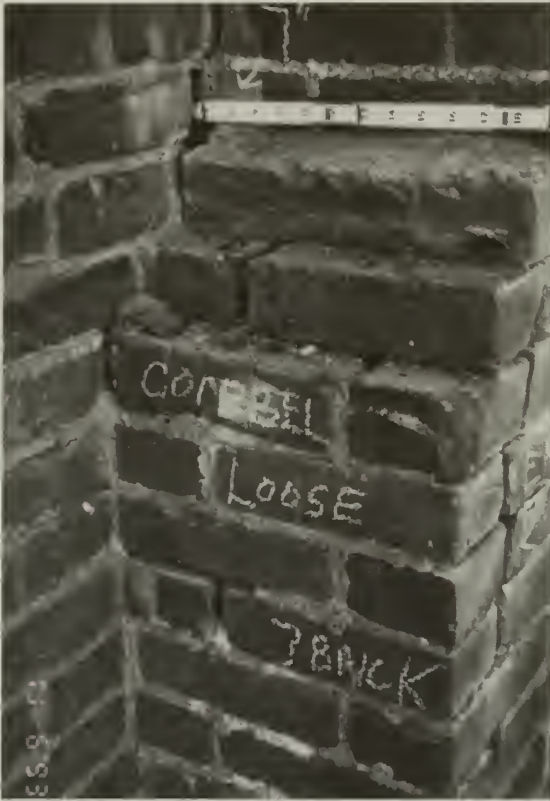
Figure 13. A complete structural survey of the building was performed and documented in order to perform the structural repairs necessary to move the building intact. All loose or eroded mortar joints were cut out and carefully pointed with a new mortar mix designed to closely resemble the original. All chimneys were braced and cabling installed around the perimeter to catch problem areas.

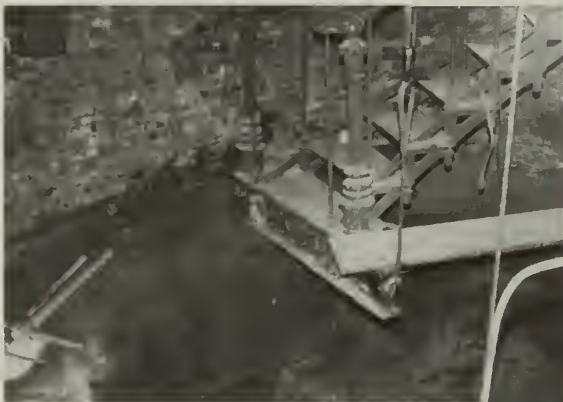
Figure 14. The concrete floor of the light tower was removed and earth excavated by hand in order to perform stabilization from the interior of the structure.

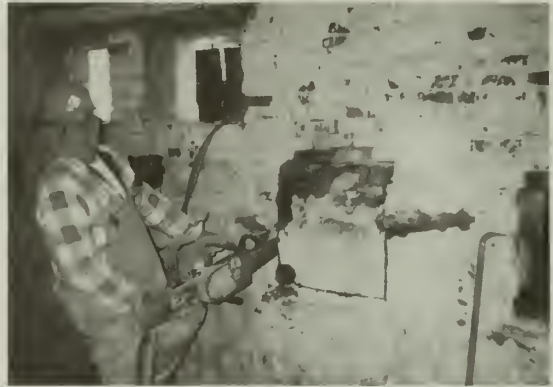
Figure 15. A hydraulic chain saw with industrial diamond teeth is being used to cut openings below the grade line for insertion of the steel beams.

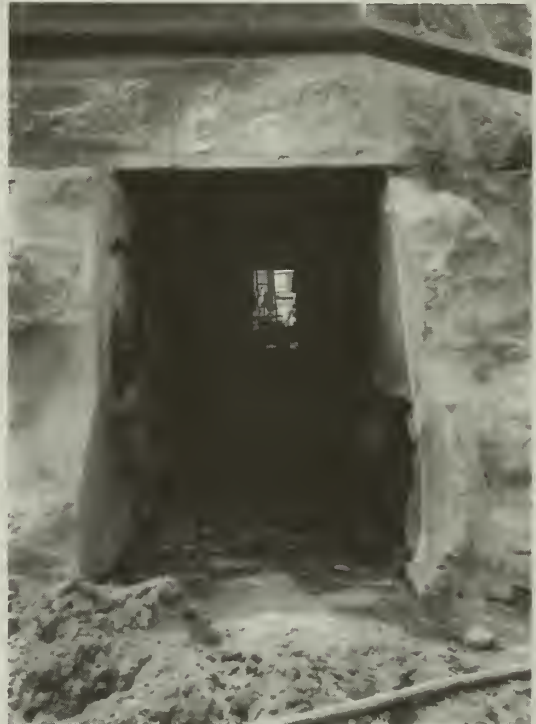
Figure 16. Close-up of the opening for the beam cut by the wire saw measuring 5 feet high by 3 feet, 6 inches wide. The depth of the cuts ranged from 18 inches to 16 feet for multiple wall cuts.

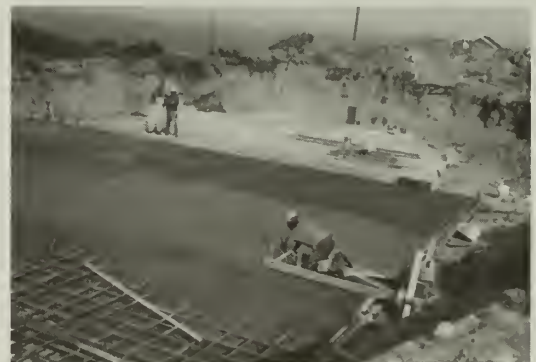
Figure 17. A foundation slab is being poured using 36 tons of rebar and 245 yards of concrete. This 18-inch-thick slab was designed to handle the dynamic load of the building travelling across the slab to its final position.

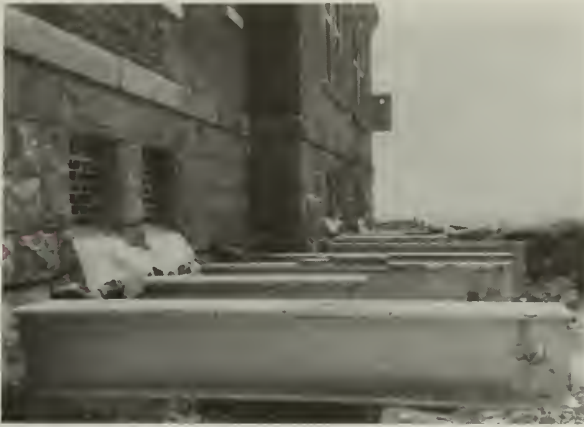
Figure 18. Large cross steel beams are inserted into the cut opening to form part of the grid that will carry the building.

An ingenious and complex system was devised to move the lighthouse over its 360-foot journey. Pete Friesen, a noted consultant in the house-moving field worked with ICC to design the move. In simplified terms, the entire weight of the lighthouse (estimated at a total of 4,000,000 pounds) was to be transferred from its masonry foundation to a grid of

crisscrossing steel beams and then pushed along tracks to its new home. The tracks were made of steel beams with case-hardened strike plates and laid on oak cribbing along a zig-zag path between the old lighthouse location and the new. In all, approximately 800,000 pounds of steel was used in the beam grid and track system.

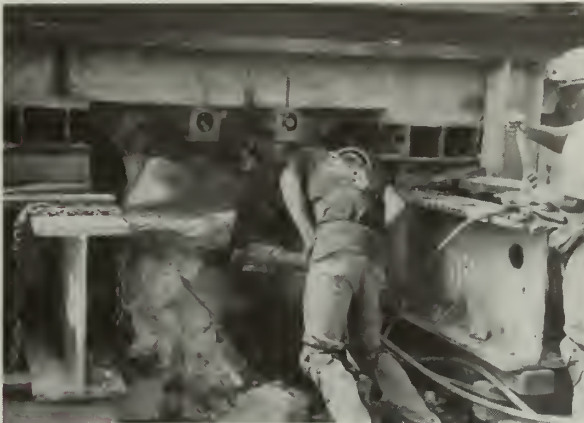
Figure 19. Once the initial lift was performed, the remaining foundation between the beams was removed.

Following the transfer of the lighthouse load from its foundation to the beam grid, all 38 hydraulic lifting jacks were activated in unison and the entire structure was raised vertically approximately 2 feet from its original elevation. The structure was then cribbed on oak timbers, tracks positioned below and parallel to the main beams, and the hydraulics for the jacks rerouted to three separate zones to allow for compensation on uneven surfaces during travel, i.e., no stress would be placed on the structure if a bump or soft spot was encountered, because the structure would roll like a ship rather than bend. By August 11, 1993, preparations were complete. The lighthouse was ready for the move.

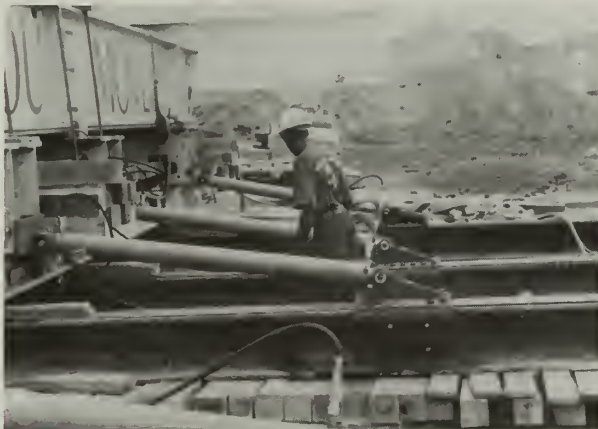
Figure 20. Four hydraulic rams set into the track steel pushed against the main steel to set the lighthouse in motion.

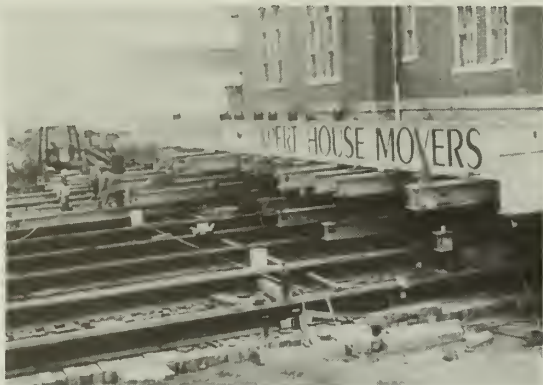
Figure 21. After the first leg of the journey was completed, the track steel was repositioned for a 90° turn.

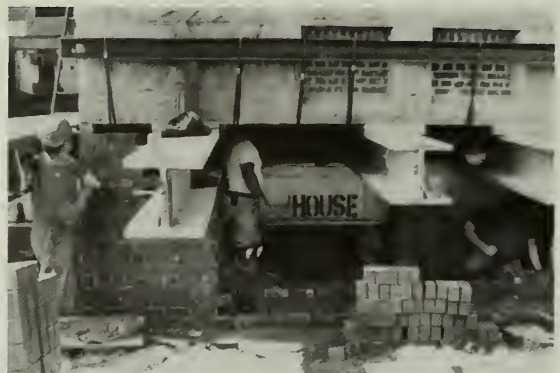
Figure 22. Construction of a new foundation around the support beams.

On August 24, 1993, Block Island Southeast Lighthouse reached its new home. It sat positioned with approximately 5 feet between the top of its new reinforced concrete slab foundation and the underside of remaining portions of its original masonry foundation. Solid brick was laid to fill the 5-foot gap (approximately 80,000 brick were required). Beams used to support the lighthouse during its journey were removed after brick was laid between the beams to carry the load. Wooden bracing and other temporary measures were removed; porches were installed; grading, landscaping, and final cleanup tasks completed. Once again, the Block Island Southeast Lighthouse rests a safe distance from the edge of Mohegan Bluffs, still facing in its original direction.

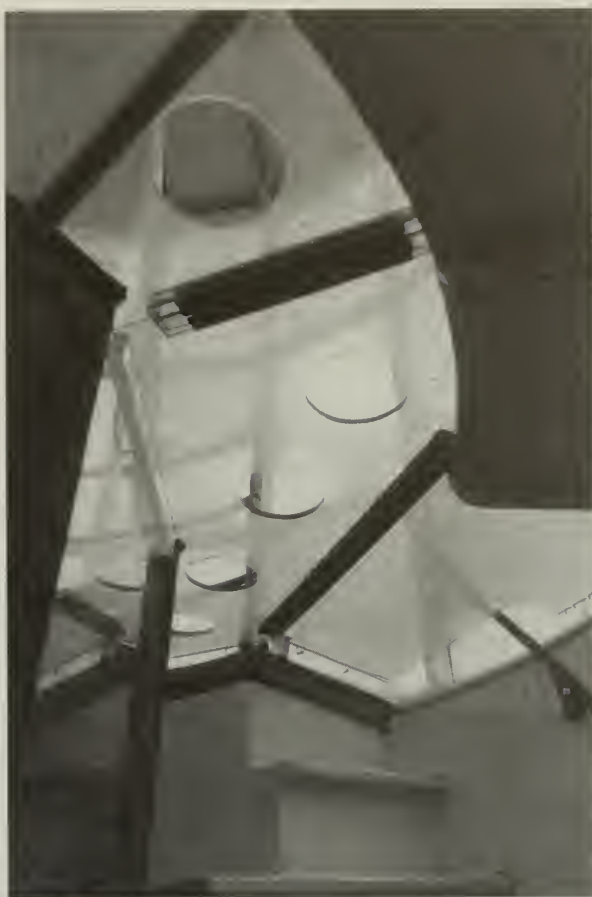
Figure 24. Visitors are prohibited from the Barnegat Lighthouse's lantern room; however, they can view it from the watch room through plexiglas sheets. While these protective sheets prevent access to the lantern room, they do collect dust and need periodic cleaning. In other lighthouses, a person is stationed in the watch room to prohibit access to the lantern room as well as control visitor behavior.

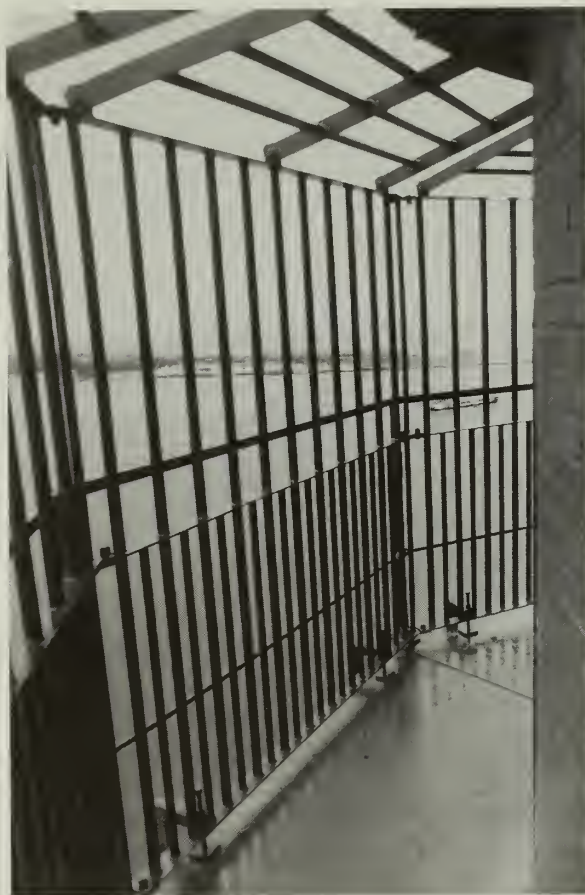
Figure 25. To protect visitors from falling or jumping from a lighthouse tower, a safety railing system or 'cage' is often built around the gallery decks. The cage at Barnegat Lighthouse was designed so that it has minimal impact on the historic structure and can be removed with little, if any, damage to the original fabric. Note that the cage is also enclosed to prevent climbing over the top.

method used by many lighthouse groups is to build a metal cage that fits around the gallery deck. The maximum space between pickets should be no more than four inches (BOCA, Building Officials & Code Administrators, International). The pickets need to completely extend to a structural element above or bend back to the tower/lantern wall so no one, even if deliberately climbing, could get over the top. One lighthouse suicide in 1995 was accomplished by climbing between overhead cage pickets with 9-inch spacing. Cages can be designed so they are attached reversibly to light towers without doing any permanent damage to the historic fabric of the structure.

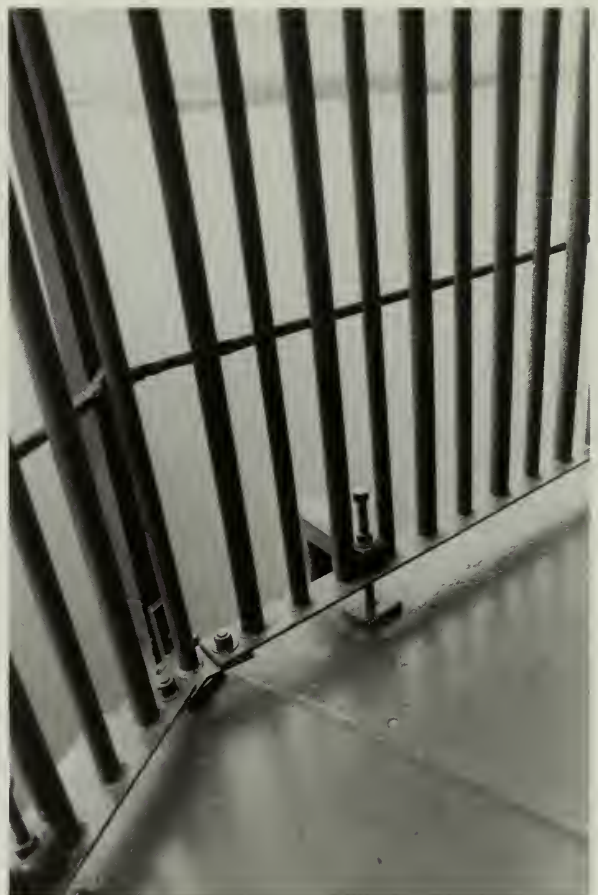
Figure 26. Note how the cage is clamped to the gallery deck, minimizing any impact on the structure's original fabric.

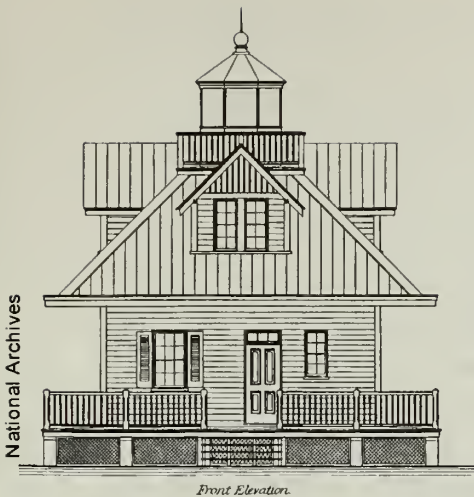
Figure 1. Front elevation drawing plan (1886) for Horn Island Light, Mississippi.
